Titanium and Its Alloys As Key Materials for Corrosion Protection Engineering

Mitsuo ISHII*1
Takashi ODA*1

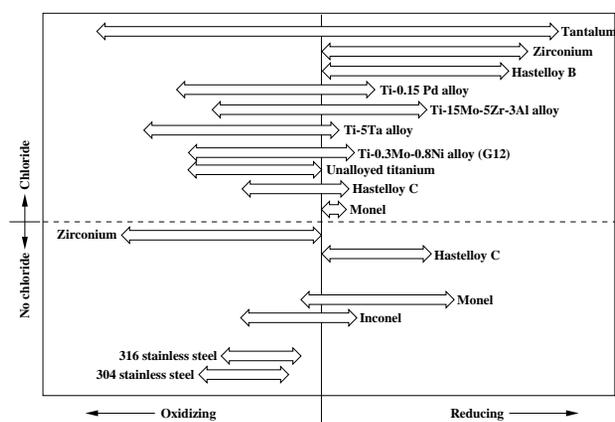
Fig.1 Range of corrosion resistance of metals¹⁾
Materials Properties Handbook; Titanium Alloy, ASM International.
 Materials Park, OH 44073-0002; Corrosion, pages 1065-1077

The major corrosion problems with titanium alloys appear to be crevice corrosion, which occurs in locations where the corroding media are virtually stagnant. **Fig. 1** shows a general comparison of corrosion resistance for titanium.

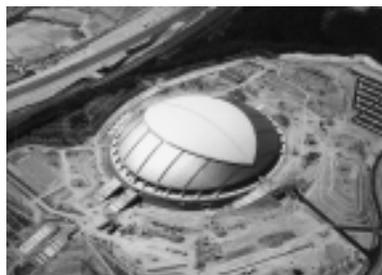
Photo 1 Oita Stadium(informally called the "Big Eye") [titanium architectural material]

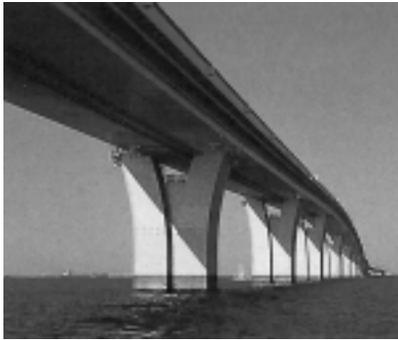
Photo 3 Piers of Tokyo TTB (Trans-Tokyo Bay Highway) [titanium-clad steel sheet]

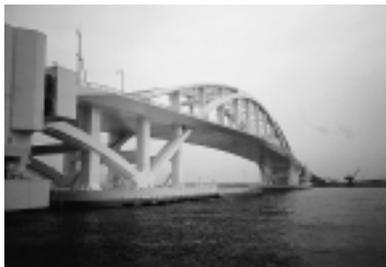
Photo 4 Pontoon of Yume - Mai Ohashi Bridge [Osaka City / titanium-clad steel sheet]
